Report No.: VS-TV-091030-01

# Test Report

Specimen : **Nuvo-8023**  
Applicant Name : **Neousys Technology Inc.**  
Applicant Address : **15F, No. 868-3, Zhongzheng Rd., Zhonghe Dist., New Taipei City, 23586, Taiwan**

| Test Standard | Vibration:MIL-STD-810G w/Change 1, Method 514.7, Procedure I, Table 514.7C-I Category 4 - Common carrier |

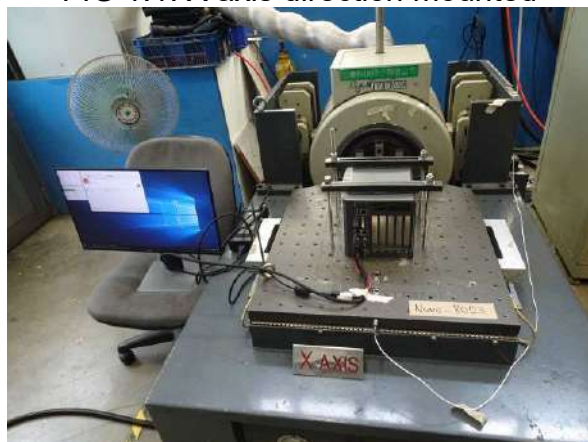
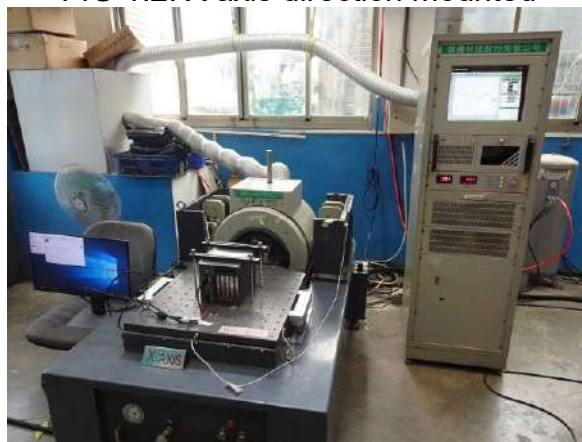
FIG 1.1: X axis direction mounted

FIG 1.2: X axis direction mounted

| FIG 1.1 ~ 1.2: | X axis direction mounted | | | | | | |

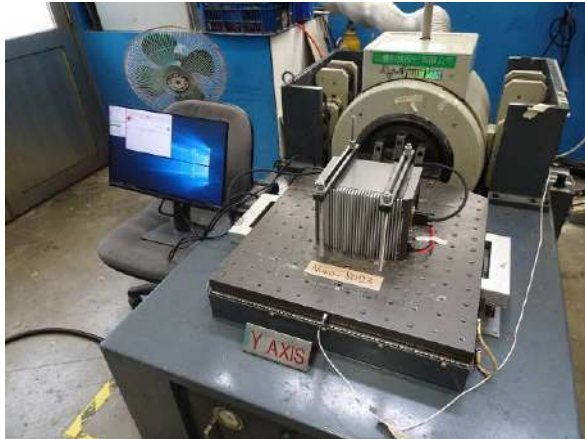
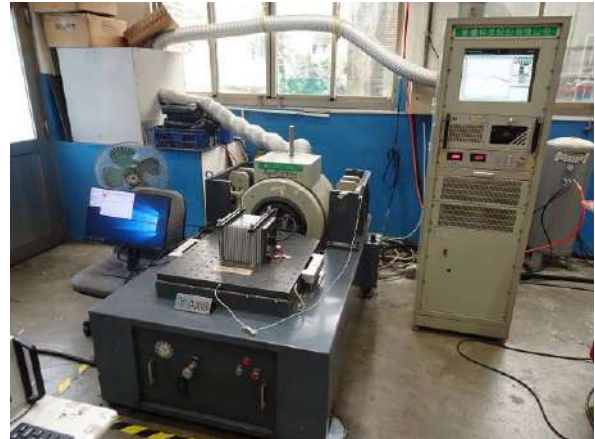
FIG 3.1: Y axis direction mounted

FIG 3.2: Y axis direction mounted

| FIG 3.1 ~ 3.2: | Y axis direction mounted | | | | | | |

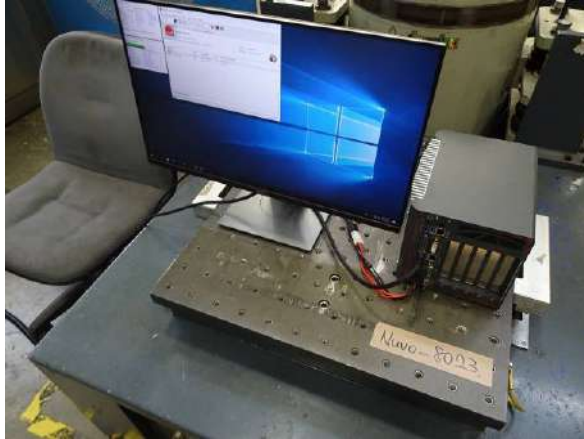
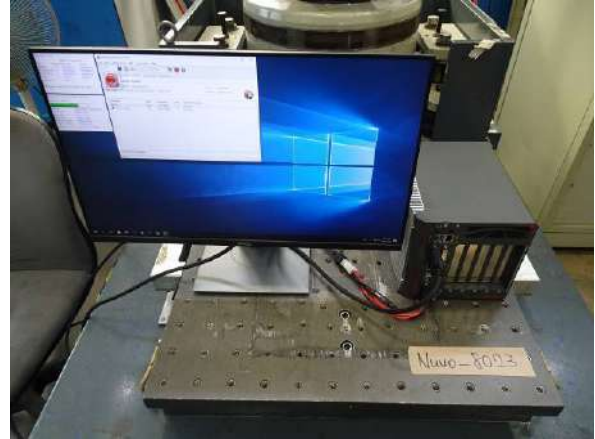
FIG.7.1 : Check after test.

FIG.7.2 : Check after test.

| FIG 7.1 ~ 7.2: | Posterior check. | | | | | | |

| Test Result | Appearance: | No external physical damage |
