**Report No.: VS-TS-091030-02**

# Test Report

| <b>Specimen</b> | <b>Nuvo-8023</b> |

### Test 3 : Shock Test

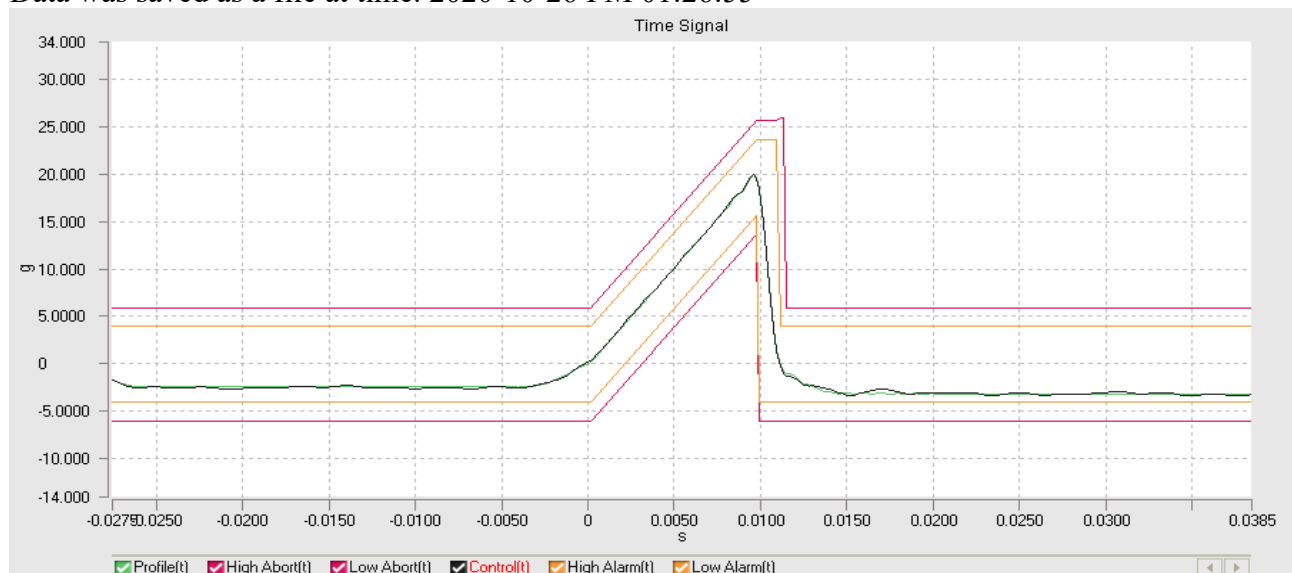
FIG.6 : +Y Axis Test screen.

Shock Type: Final Peak Saw Tooth

Mag: 20.00 g

Pulse Duration: 11 ms

Demand peak: 20.000 g

Control peak: 20.012 g

Current Pulses: 3

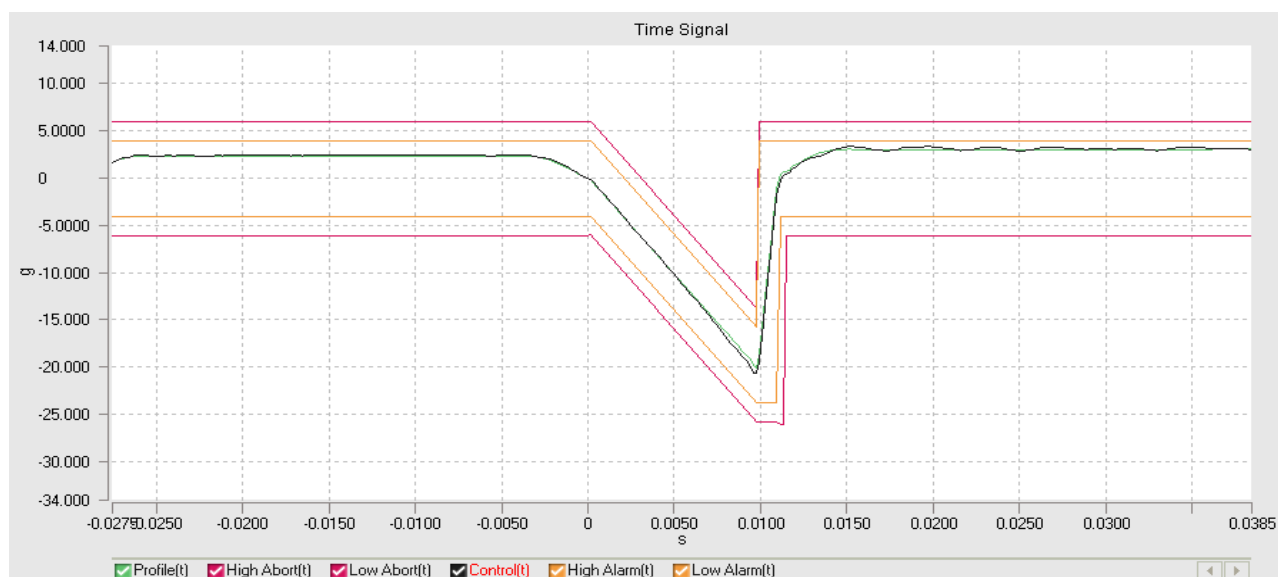
FIG.8 : -Y Axis Test screen.

Shock Type: Final Peak Saw Tooth

Mag: 20.00 g

Pulse Duration: 11 ms

Demand peak: 20.000 g

Control peak: 20.611 g

Current Pulses: 3

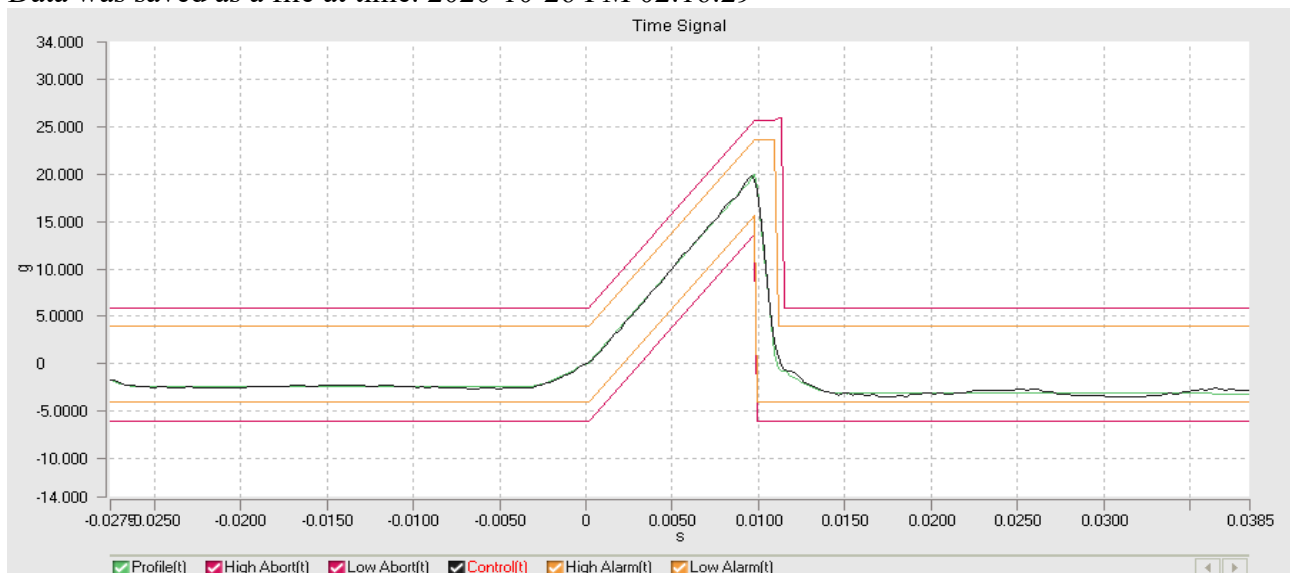
FIG.10 : +Z Axis Test screen.

Shock Type: Final Peak Saw Tooth

Mag: 20.00 g

Pulse Duration: 11 ms

Demand peak: 20.000 g

Control peak: 19.938 g

Current Pulses: 3
